Manhole Inspection Summary

Manhole # S01UU1001MH

Location Address: **3801 GLEN AVE**

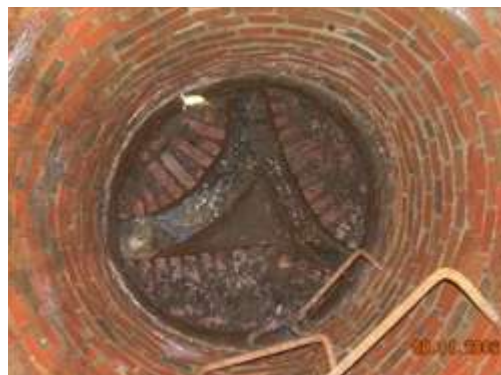
Top View

Adjustment, Corbel and Barrel infiltration.
Evidence of surcharge - Bench debris.

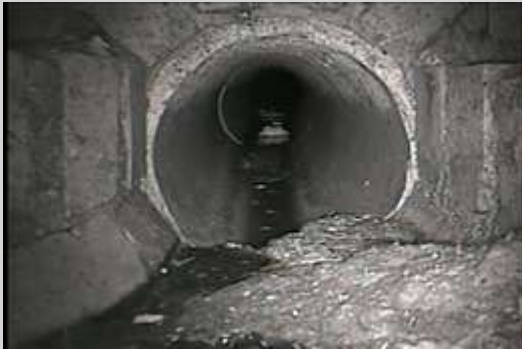
8 in. Circular Gravity Sewer Pipe Out @ 12 O'Clock

Channel debris.

Deposits: ☐ None ☒ **Mud** ☐ Sludge ☒ **Debris** ☐ Grease

Silt Depth: **0.5** (in.) Deposits Extent: **Light**

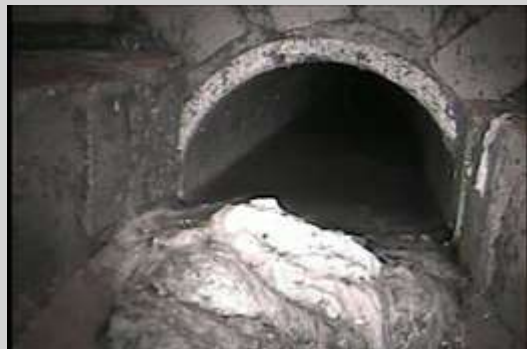
8 in. Circular Gravity Sewer

Channel debris.

Deposits: ☐ None ☒ **Mud** ☐ Sludge ☒ **Debris** ☐ Grease

Silt Depth: **1** (in.)
